## DESIGN OF GNSS NETWORKS FOR MONITORING EARTH DAMS DEFORMATIONS

**ABSTRACT.** The paper presents a series of results regarding the application of GNSS technology for measuring displacements to earth dams. An appropriate horizontal and vertical deformation-tracking network must be established for the rapid monitoring of earthmoving movements. Data obtained from the monitoring network can be used in the earth dam stability analysis program. Periodic tracking of earth dams using GNSS technology provides high accuracy of spatial distortions. The results of the paper show the application of GNSS technology to monitor the deformations of the Podisu earth dam located on the Sheep Valley River in Iasi County. In the first stage of research (2019 and 2020), the local geodetic tracking network was created. To monitor the dam, four control landmarks were placed on the crest of dam and seven landmarks on the downstream slope. In the second stage of the research (year 2021) the measurements of the displacements at the earth dam were performed. The GNSS monitoring method has the advantage of positioning the target quickly, statically, and with high accuracy. The measurements used fixed statio

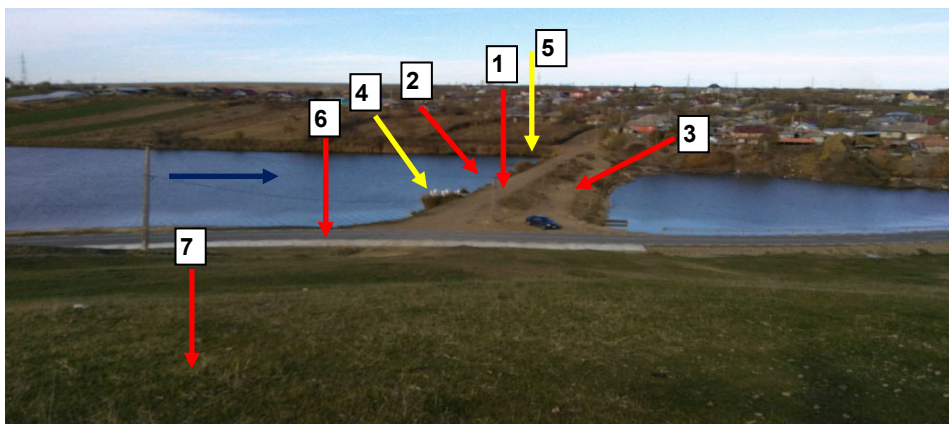
**Figure 1 - General view of the Podisu dam: 1 – crest of a dam; 2 - upstream slope; 3 - downstream slope; 4 - bottom water outlet C1; 5 - funnel overflow C2; 6 - road; 7 - the right slope (source: author)**

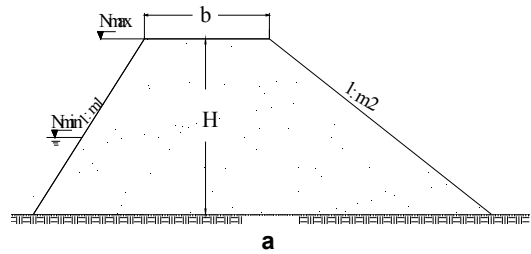
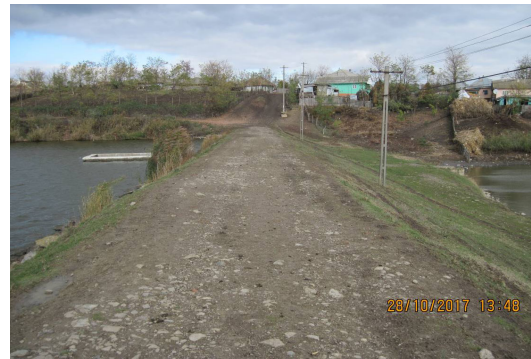
Figure 3 - Podisu earth dam: a - cross section initially executed (Sbiera, 2006); b - general view of the dam, year 2021 (source author)

The Podisu dam is homogeneous in structure and was constructed in 1962, from land taken from the location area. The cross section of the dam has a trapezoidal shape and the geometric parameters are as follows (Sbiera, 2006) (Fig. 3):

- maximum height 3.90 m;
- length of dam crest 104.0 m and width 4.50 m;
- the slope of the upstream shell 1: 1.0 and the downstream shell 1: 2.0.

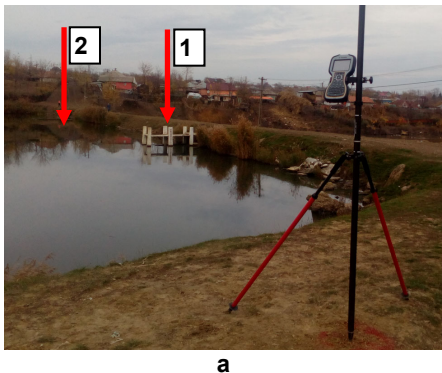
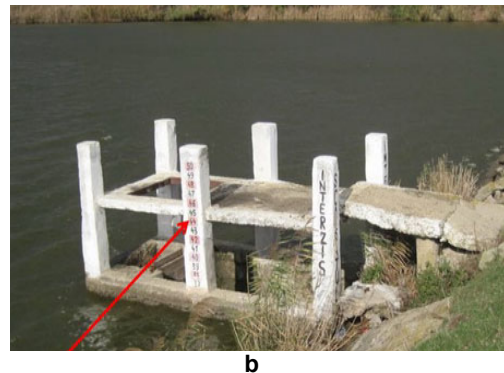
Figure 4 – Flow evacuators of the Podisu dam: a - general view upstream of the dam with the positioning of the evacuators; 1 - C1, 2- C2; b - detail regarding the C1 evacuator and the position of the water meter (source: author).

The evacuators are located in the body of the dam on the upstream slope as follows (Fig. 4a): C1 on the right and C2 on the left.

The C1 evacuator structure is a manoeuvring tower provided with a spillway on three sides (Fig. 4b). The front spillway has a ridge at a lower level, and over it, are mounted cofferdams to regulate the water level in the lake and the discharged flow. The bottom outlet pipe has a mixed cross section (rectangle semicircle) with dimensions of 1.00 x 1.60 m (Sbiera, 2006).

constructions are made of reinforced concrete. The Podisu dam does not have control parts installed for measuring the movements on the crest and face slopes, a situation determined by its category of importance. Only the water level in the lake is measured directly, at the water meter located on the wall of the C1 evacuator (Fig. 4.b).

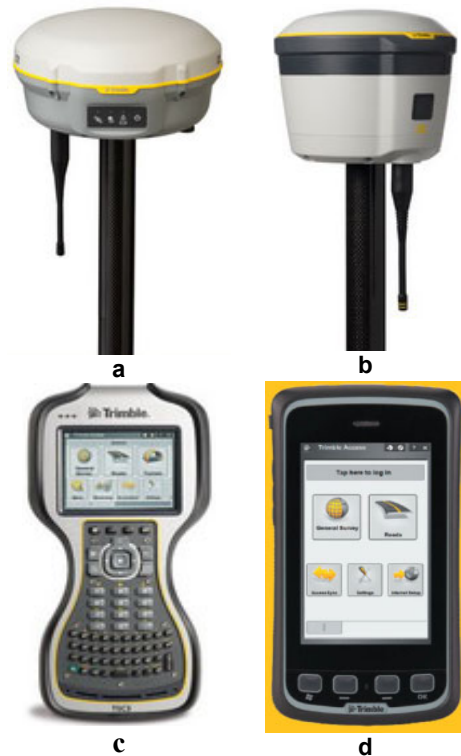
**Figure 5 - GNSS equipment used for measurements: a - Trimble R8S receiver; b - Trimble R2 receiver; c - Trimble TSC3 control unit; d - Trimble Slate control unit**

- choice of GNSS equipment; it consists of Trimble R8S, Trimble R2 receivers and Trimble TSC3 and Trimble Slate control units (*Fig. 5*);

For the Podisu dam, four Trimble GNSS receivers, three R8S receivers and one R2 receiver were used for the measurements. The control units used were a Trimble TSC3 and a Trimble Slate.

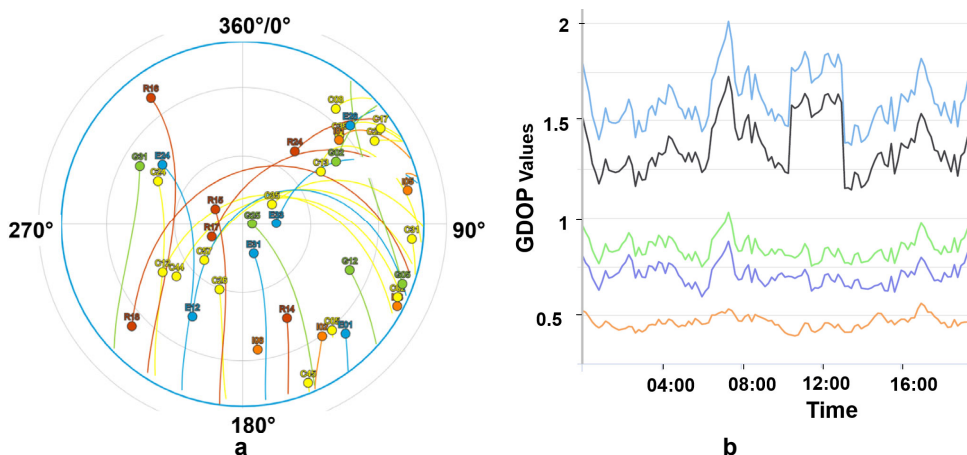
**Figure 6 - Observation planning: a – satellite trajectories: ● - GPS; ● - GLONASS; ● - GALILEO; ● - BEIDOU; ● - QZSS; ● - IRNSS satellite constellations; b – the graph of GDOP value: cyan line – geometric; black line – time; green line – positioning; blue line – vertical; orange line - horizontal (source: Trimble GNSS Planning Online).**

- *Fig. 6* shows the planning of observations for the first cycle of measurements conducted in November 2019.

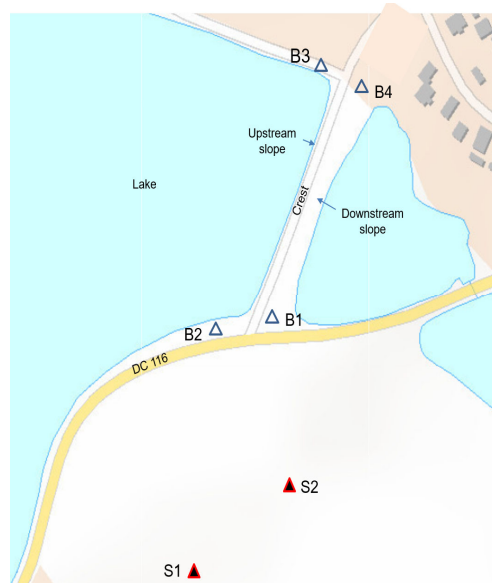
**Figure 7 - Geodetic monitoring network designed for the Podisu dam**

The designed local geodetic tracking network consists of the following components (Fig. 7):

- two reference points (S1, S2) located on the right slope in the vicinity of the dam;
- four station points (B1, B2, B3, B4) located near the dam, in stable areas.

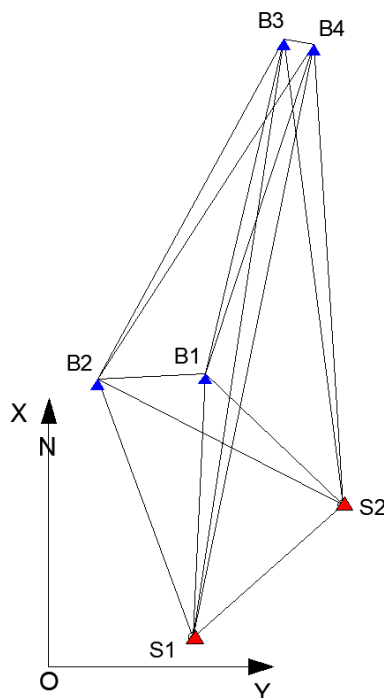
**Figure 8 - GNSS Representation vectors in the monitoring network: red points – fixed reference points; blue points – new points in the local network**

Straight segments that connect the stationary points according to the projected vectors represent the scheme of the observation sessions (Fig. 8). GNSS vector processing was performed automatically in the Trimble Business Centre program. In 2019 (cycle 0) there were 60 GNSS vectors and in 2021 (cycle 1) there were 36 GNSS vectors.

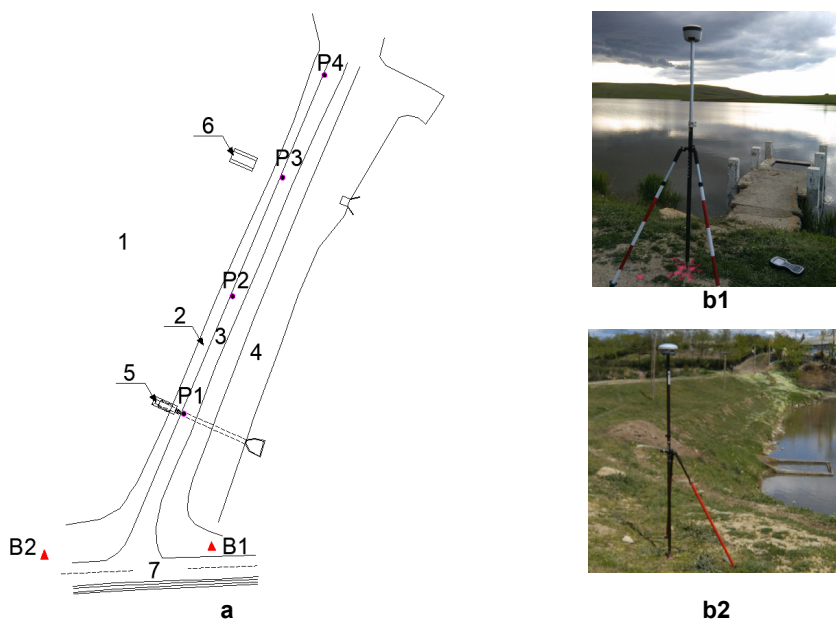
Figure 9 - Organisation and performance of measurements: a - dam representation scheme, 1 – water storage, 2 – upstream slope, 3 – dam crest, 4 – downstream slope, 5 – flow evacuation construction C1, 6 - flow evacuation construction C2, 7 – road; B1 and B2 – station points; P1, P2, P3, P4 – control points located on the dam crest; b – positioning the receivers: b1 – in control point P1, b2 – in station point B1.

In order to monitor the movements at the Podisu dam, four control points were monitored on the crest (P1-P4) (Fig. 9). At these points, rapid static GNSS observation sessions were conducted, with fixed stations at points B1 and B2, previously determined within the local geodetic tracking network.

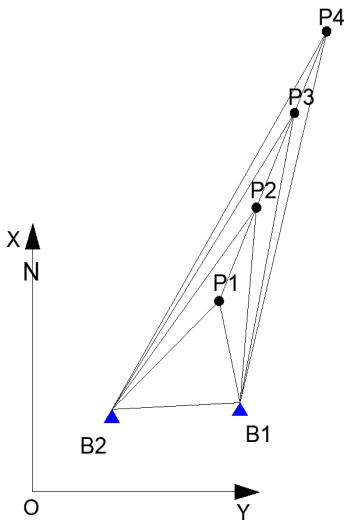
Figure 10 - GNSS vectors following the landmarks on the dam crest: B1, B2 - station points; P1, P2, P3, P4 - control points

To determine the control points (P1-P4), three series of measurements were performed, resulting in 18 GNSS vectors (Fig. 10). The spatial coordinates of the control points fixed to the crest of a dam, resulting from the two cycles of measurements performed in May and July 2021 were centralised in Table 3.

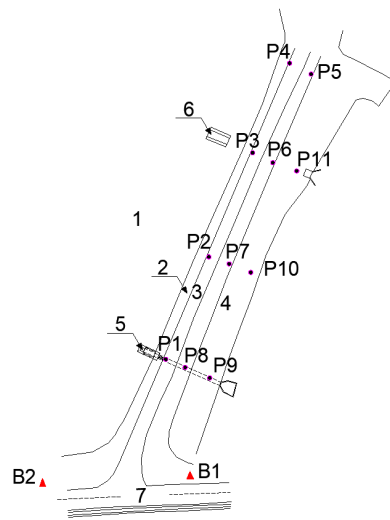
Figure 11 - Plan with control points on the dam crest and downstream slope: 1 - water storage; 2 - upstream slope; 3 - dam crest; 4 - downstream slope; 5, 6 - flow evacuation (C1, C2); 7 - road; B1, B2 - station points; P1...P4 - control points on the dam crest; P5...P11 - control points on the downstream slope.

In July 2021, a set of measurements was taken and the coordinates of the 11 control points fixed on the dam crest (P1 ... P4) and the downstream slope (P5 ... P11) were determined in relation to the station points B1 and B2 (Fig. 11).

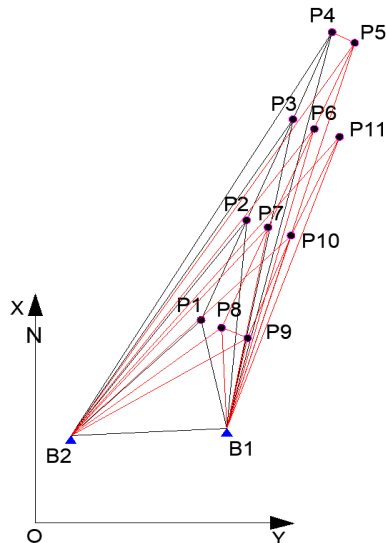
Figure 12 - The complete dam tracking network and GNSS vectors: B1, B2 - station points; P1...P4 - control points on the crest; P5, P11 - control points on the downstream face slope

Four Trimble GNSS receivers were used for field data collection and 10 measurement sessions were performed. The duration of a measurement session was about 11 minutes. During the processing of the measurements through the Trimble Business Centre program, 60 GNSS vectors were obtained (Fig. 12).
